## INSTALLATION INFORMATION

### ***788 V1.10 software upgrade***

### ***Installation procedure.***

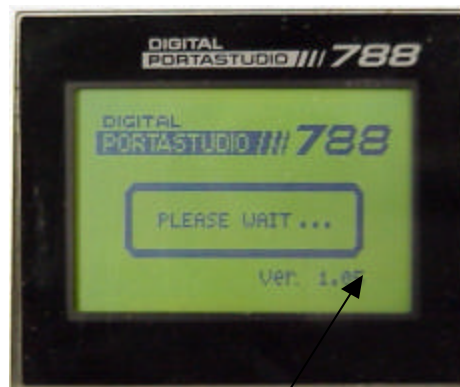
Ex.1b

1. Turn on the 788 and confirm that your unit's software is less than V1.10 by observing the version level in the display window. (See Ex.1b)
2. Turn the power off and remove the power adapter from the unit and wall socket before starting the installation.
3. Turn the unit over and remove the cover (16 screws). (See Ex. 1c)

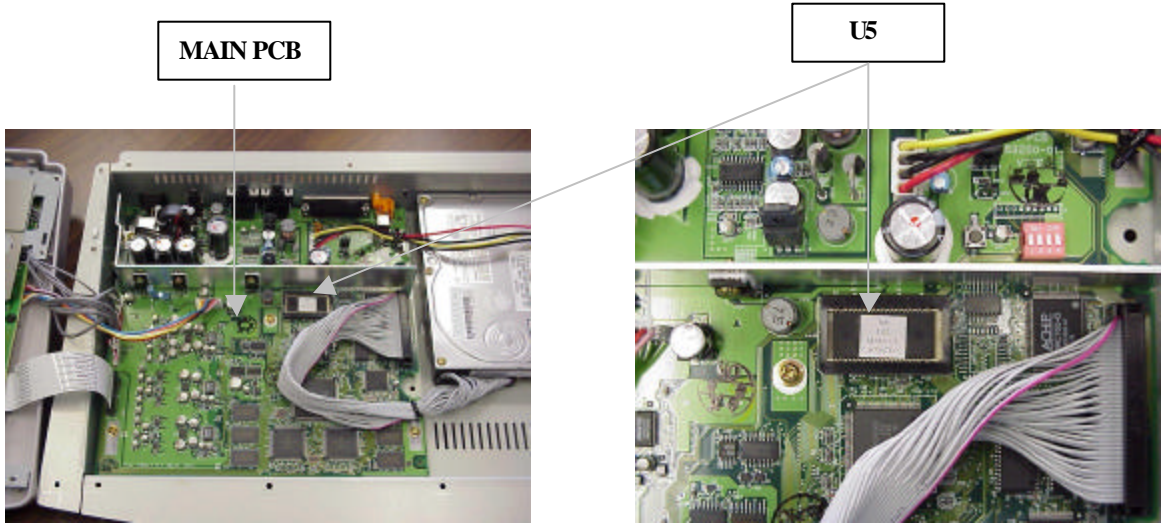
Ex. 3

The EPROM can be removed by sliding the black plastic locking device in the direction of the arrow etched onto the ring. The holder then lifts from the PCB allowing removal of the EPROM. Reverse the procedure to install the new EPROM.

5. Locate and remove U5 from the MAIN PCB. Install the new version EPROM. (See Ex.3)
